**IC693DSM302**

**GE Fanuc**

**Series 90-30**

IC693DSM302-AE

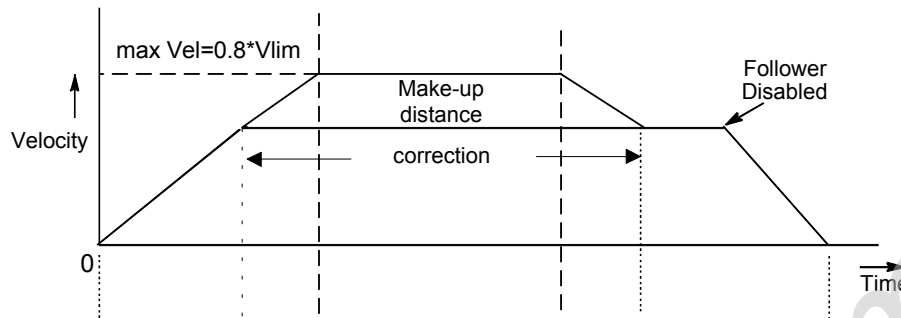
The Follower Axis Ramp Control Function is enhanced in DSM firmware release 1.30. The enhancement improves motion smoothness. Prior to this release, when the follower was active and the master in motion, the acceleration/deceleration control during the make-up correction phase was not controlled by a velocity profile. This could cause unwanted machine shock. The enhanced method uses a trapezoidal velocity profile to address this problem. During the entire make-up correction phase, the acceleration/deceleration is limited to the jog acceleration value. Also during the correction, the velocity is not allowed to exceed the maximum. Appropriate warning/error codes notify the user about abnormal operation (see error table below).

The figure below shows the velocity profile during the follower ramp cycle. *Note: The enhanced follower make-up may affect existing applications that use the old follower make-up feature.*
